DNA-TR-81-162

CHARGING AND DISCHARGING OF SPACECRAFT THERMAL CONTROL DIELECTRICS

Mission Research Corporation
5434 Ruffin Road
San Diego, California 92123

Technical Report

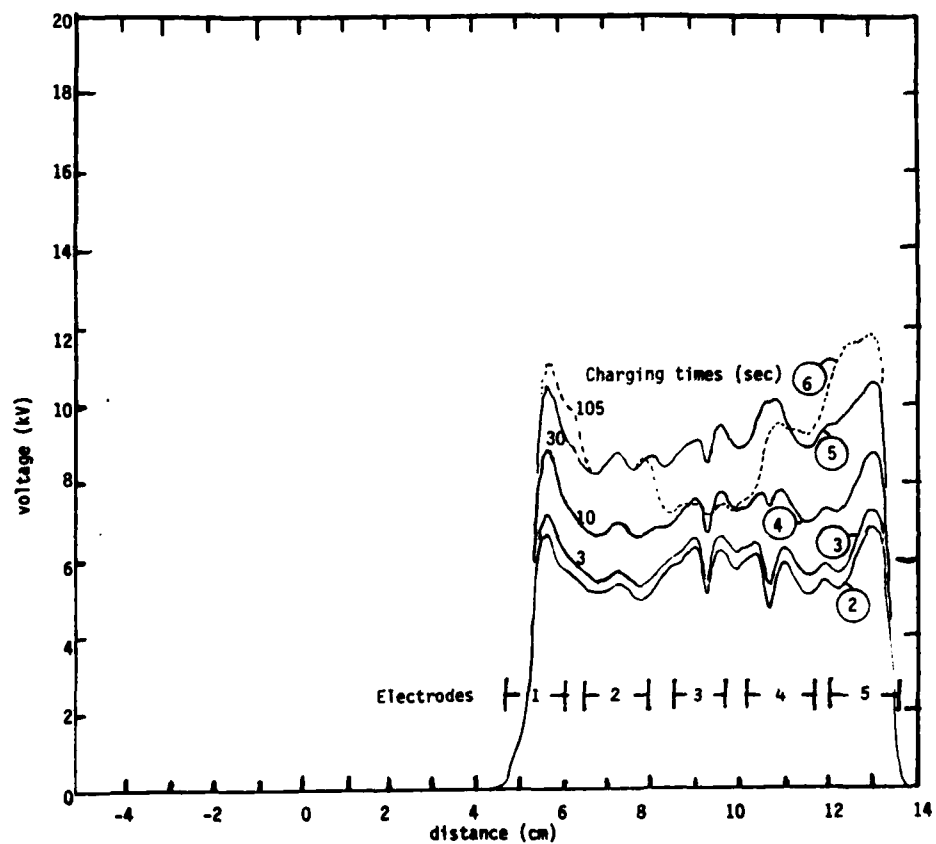
Figure 79. Charging potential profiles on 0.030 cm cover glass with 0.7 nA/cm^2 of 16 keV electrons. Charging times are indicated.

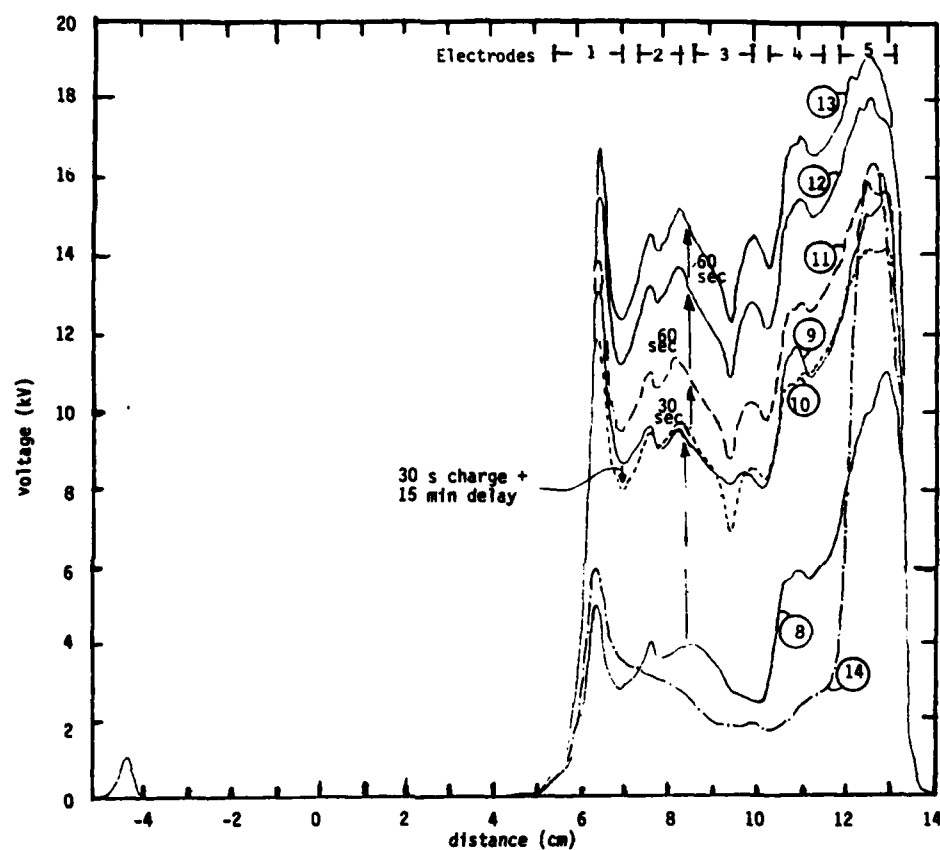
Figure 80. Recharging after discharge on 0.030 cm cover glass with 0.6 nA/cm^2 of 26 keV electrons, leading to a discharge.

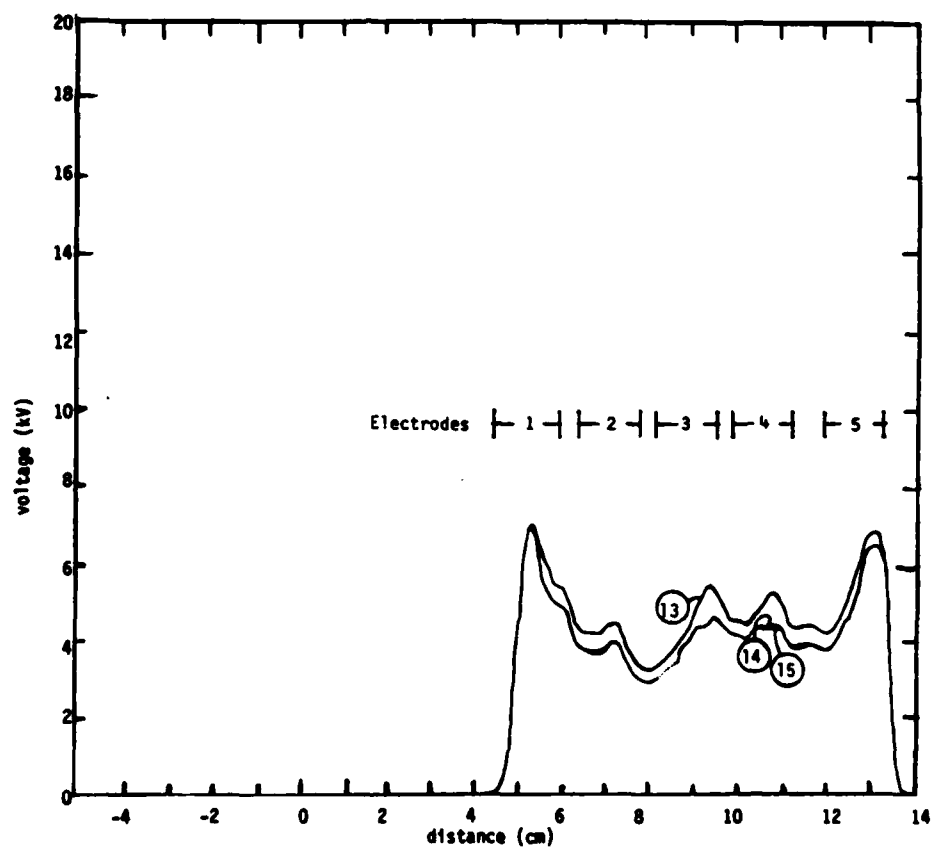
Figure 81. Comparison of potential profiles on 0.030 cm cover glass after a fifteen minute delay without lights and two minute delay with lights.

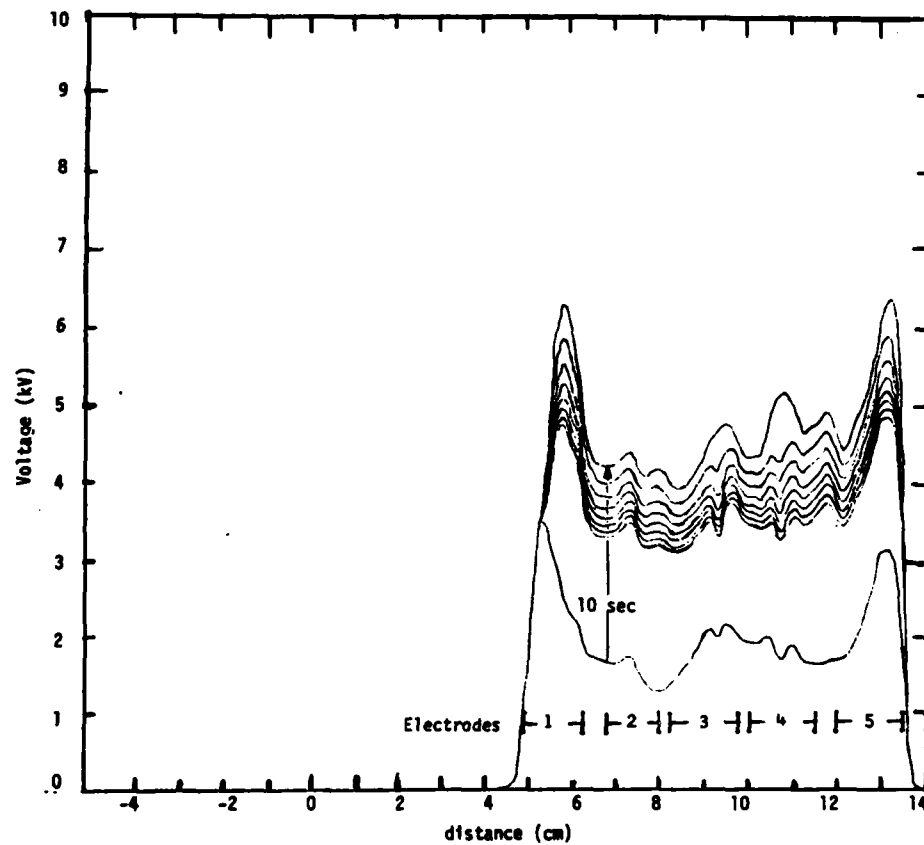
Figure 82. Decay of voltage profile after 10 second charging with 4 nA/cm^2 of 11 kV electrons; 3 minutes between each sweep with beam off.

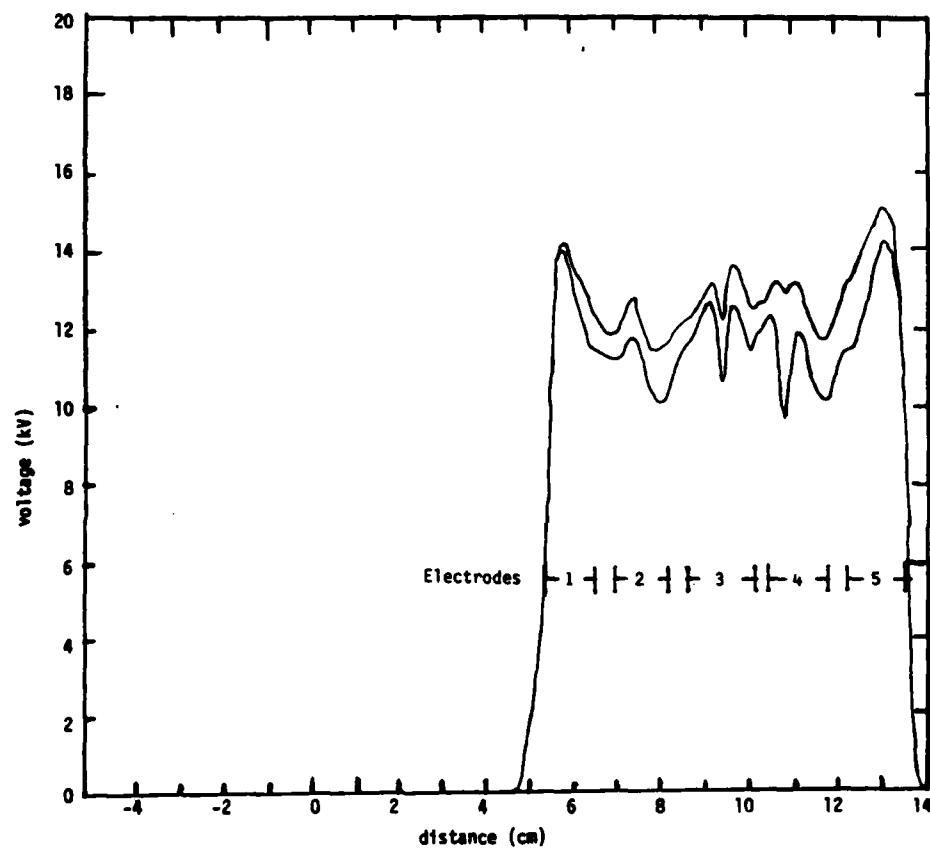
Figure 83. Decay of voltage profile on solar cell cover glass overnight.

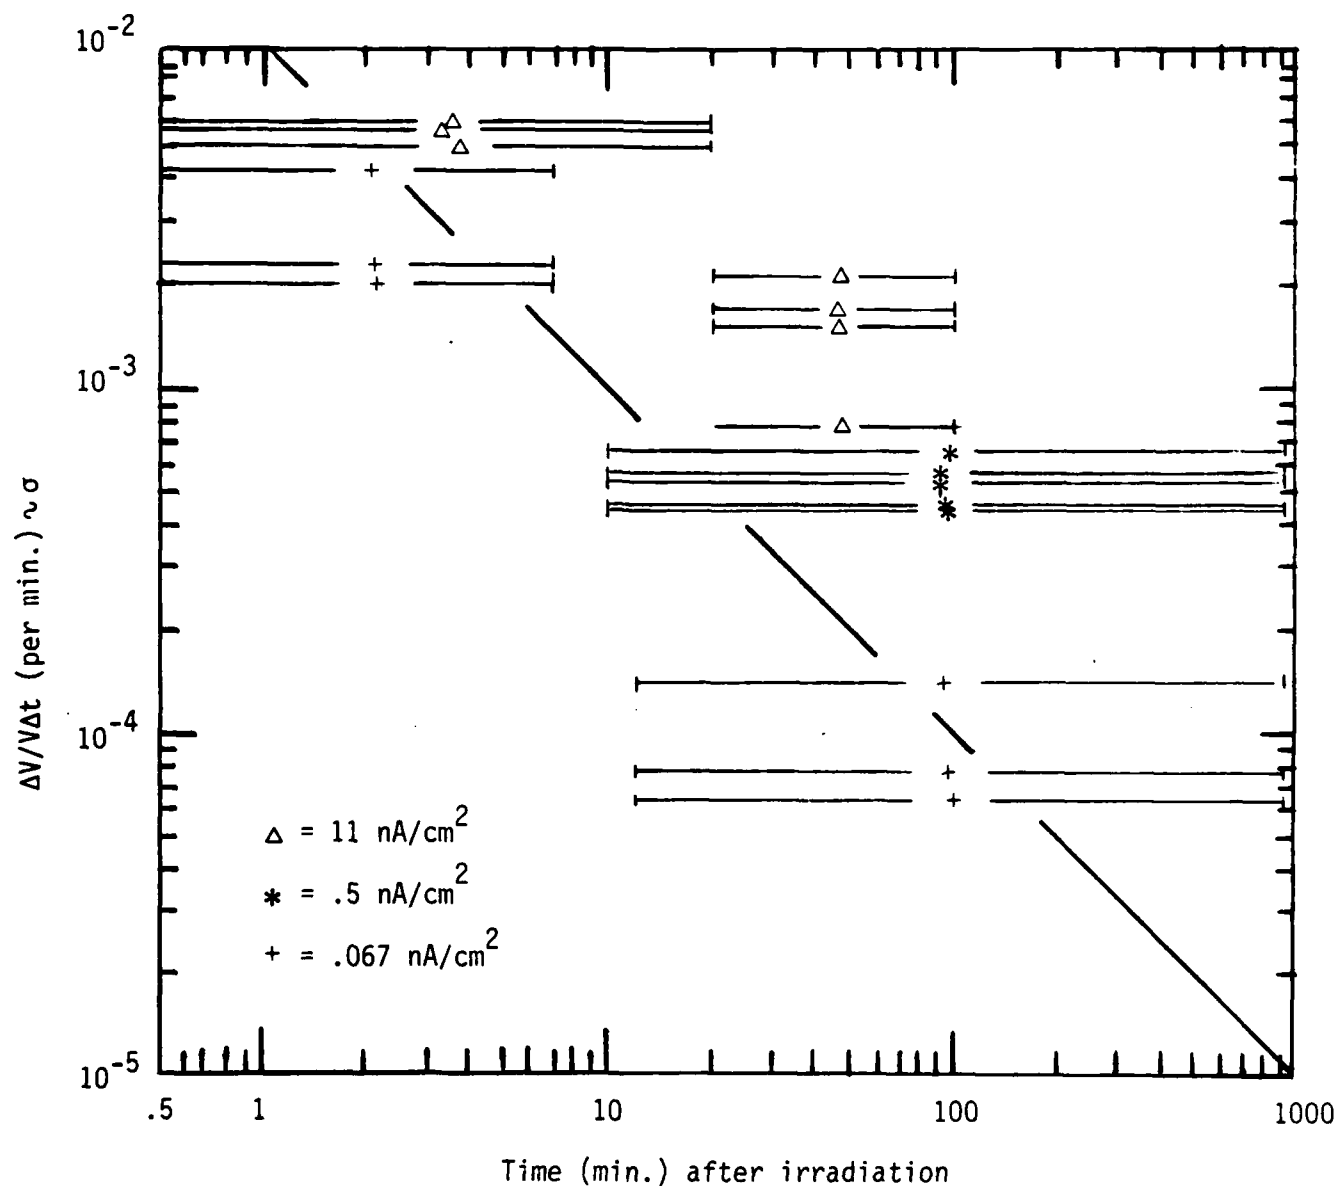
Figure 84. Enhanced delay conductivity in the non-irradiate portion of solar cell cover glass - with the irradiated current density as a variable.

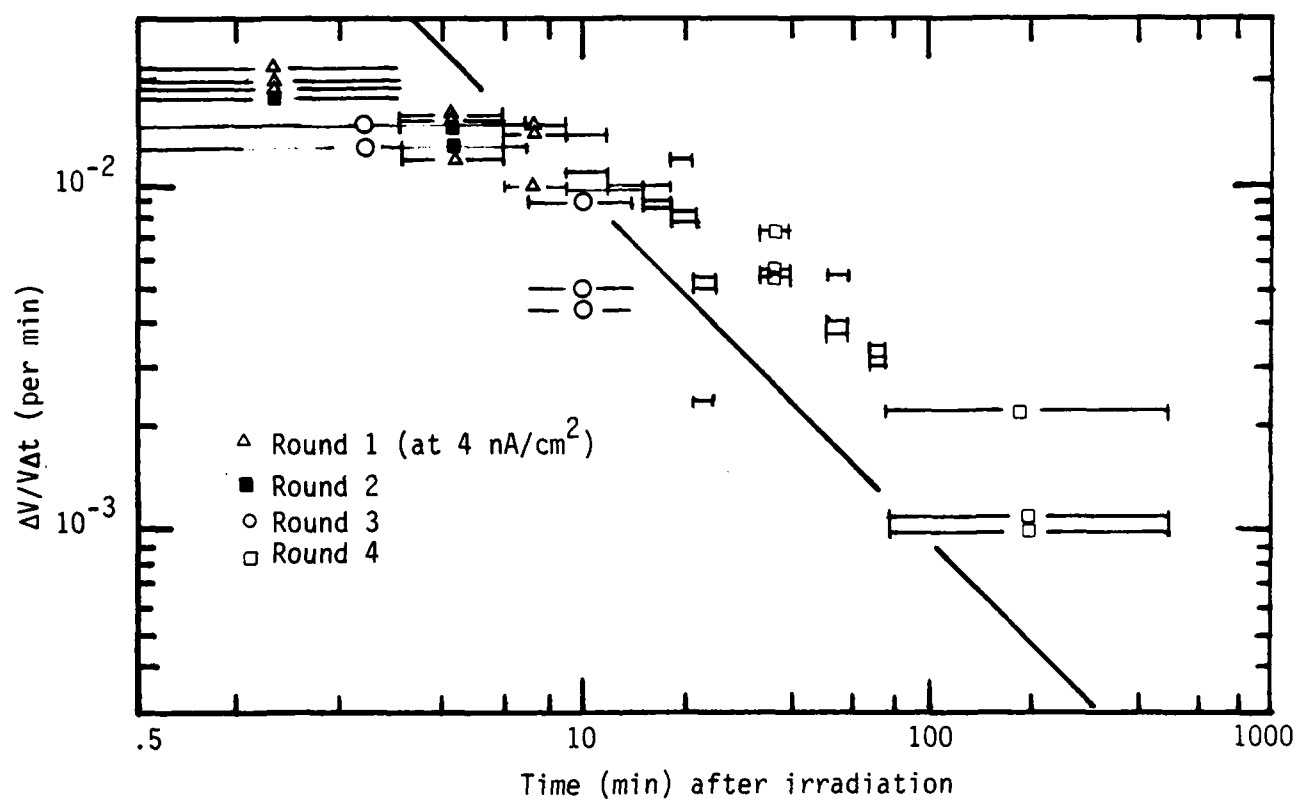
Figure 85. Enhanced delayed conductivity in the non-irradiated portion of solar cell cover glass.

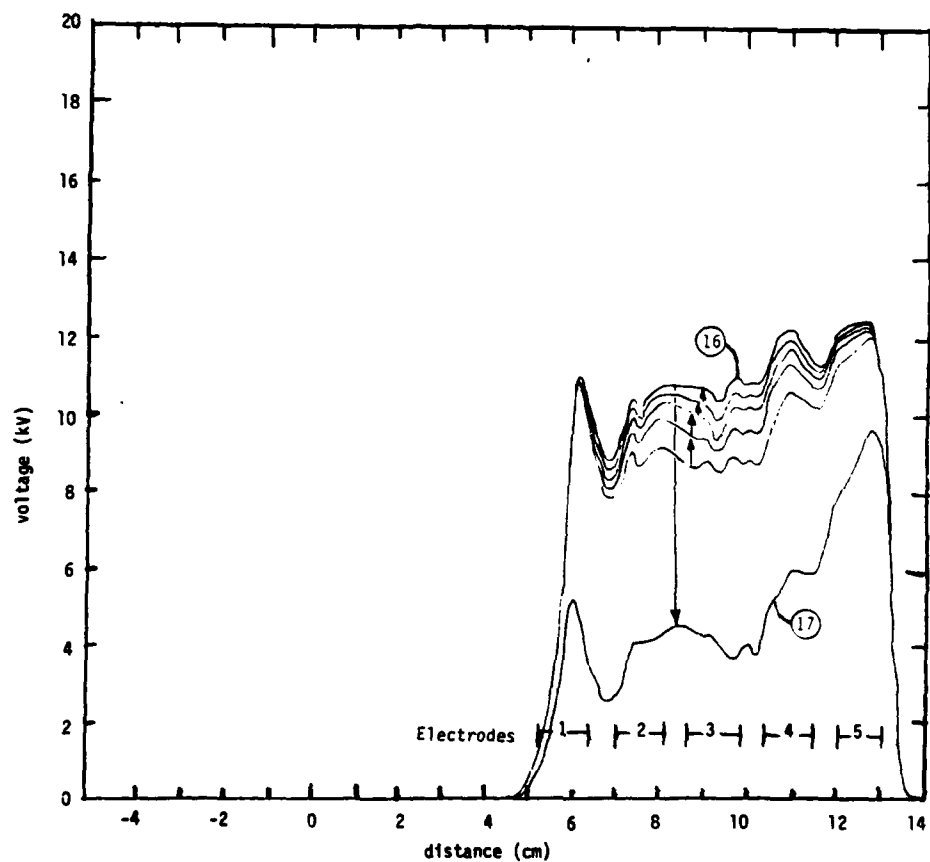
Figure 86. Charging a 0.030 cm cover glass with 0.5 nA/cm^2 of 16 keV electrons, leading to discharge 3:53.

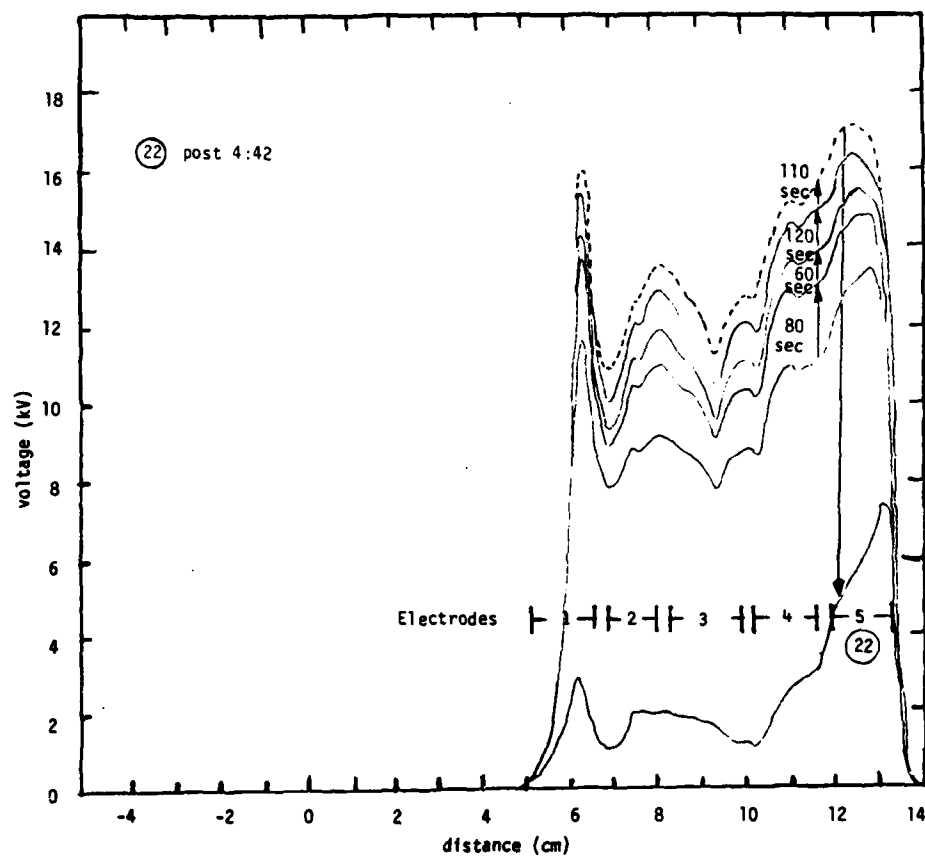
Figure 88. Charging 0.030 cm cover glass at around 0.3 nA/cm^2 , 26 kV, leading to discharge 4:42.

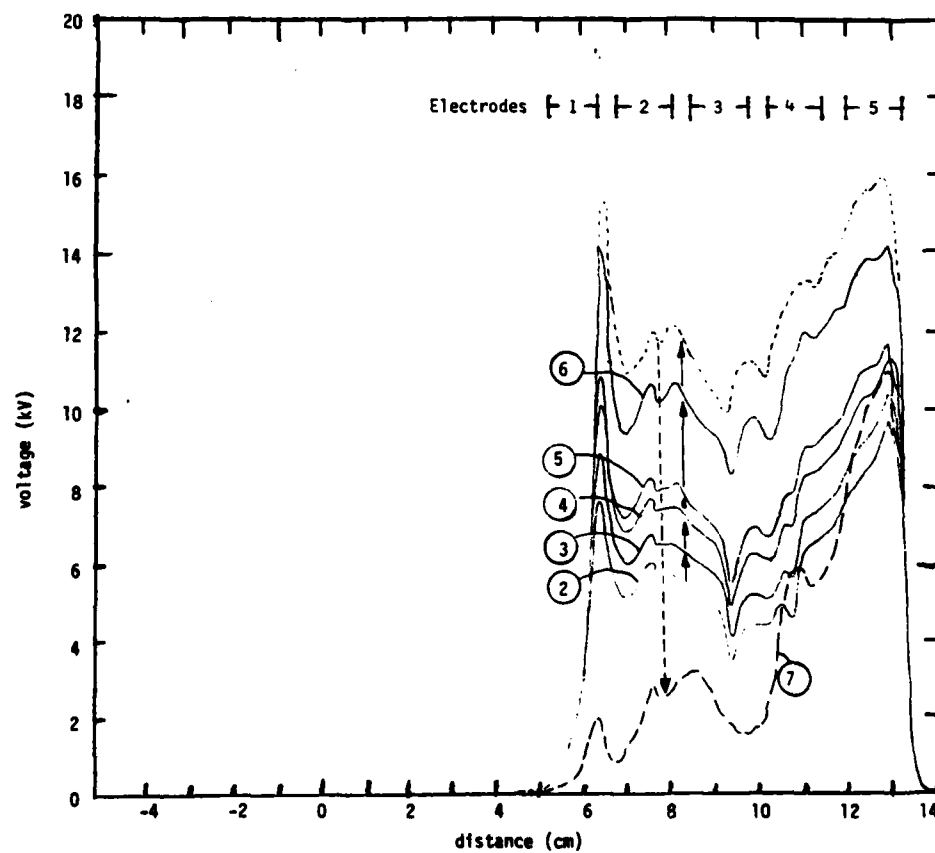
Figure 90. Charging profiles on 0.03 cm cover glass with 0.3 nA/cm^2 , then 0.6 nA/cm^2 of 26 keV electrons, leading to discharge 11:41.

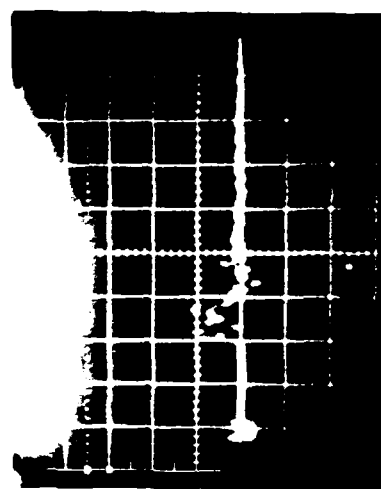
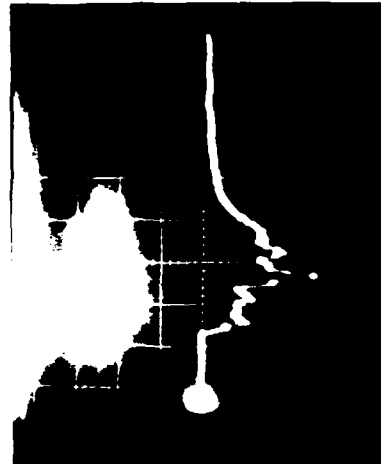
Figure 91. Transient record of discharge 11:41 on 0.03 cm solar cell cover glass exposed to 26 kV electron.

Figure 91 is the transient record of event 11:41, and resembles the two previous ones very much. Here again we see a signal that arrives at the same time on channels 2 through 5, and another signal (perhaps) that appears $\approx 100 \text{ ns}$ later on channels 1, 2, and 3. The blow-off collector also shows an early charge movement followed by a jump in current at $\approx 100 \text{ ns}$. The back surface electrodes added together recorded $\approx 20\%$ of the charge which left the sample, and the blow-off collector recorded $\approx 30\%$ of the charge which left the sample (as inferred from the drop in voltage on Figure 90).

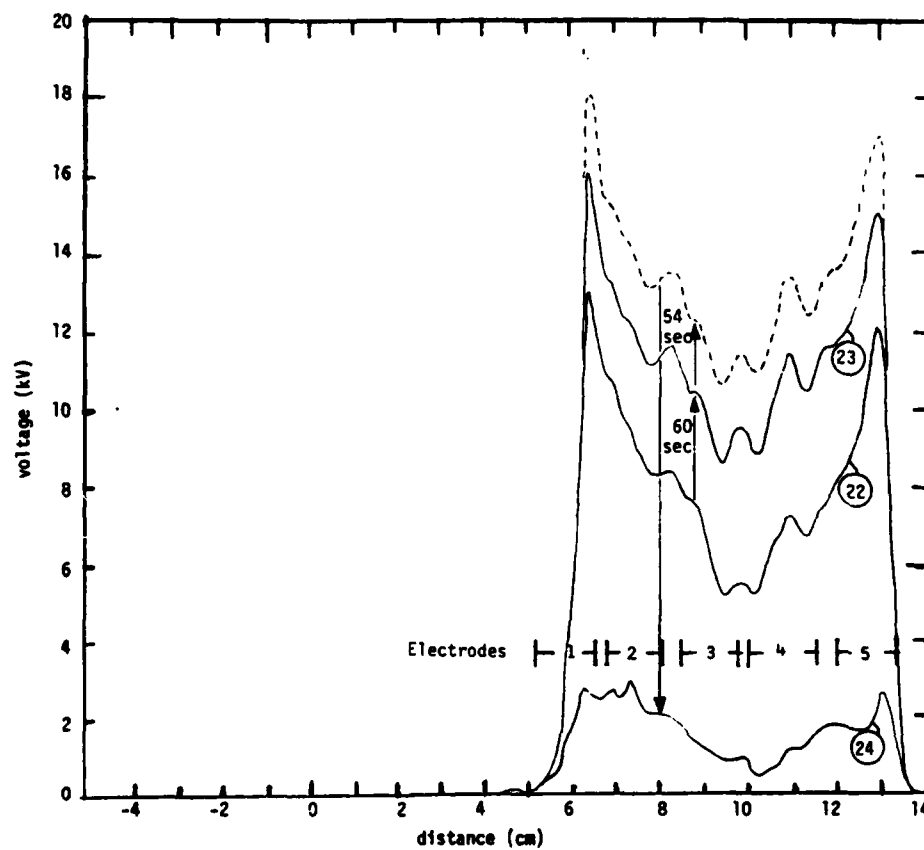
Figure 92. Charging 0.03 cm cover glass with 1.3 nA/cm^2 of 26 keV electrons, leading to discharge 3:21. Charging times are indicated.

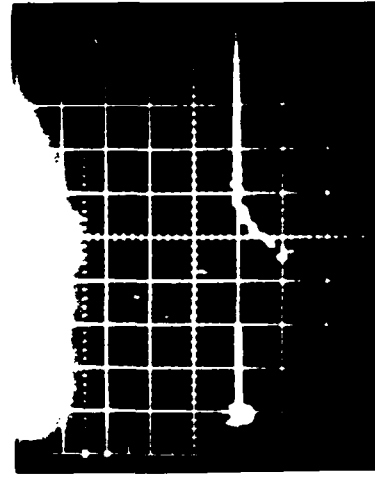
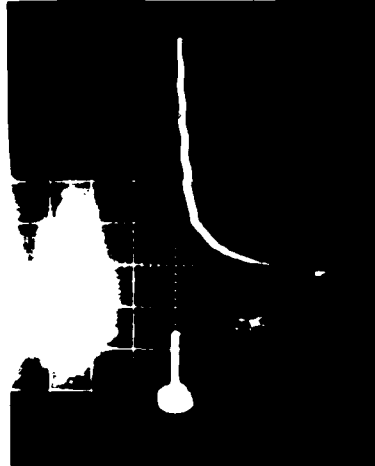
Figure 93. Transient record of discharge 3:21 on 0.03 cm solar cell cover glass exposed to 26 kV electron.

Figure 93 is the transient record for event 3:21. This event looks very much like event 4:42 (Figure 89), except that channels 4 and 5 both show a definite bipolar signal. The negative part indicates either a) charge which had previously left the sample returned, or b) charge from another portion of the sample arriving. The amount of negative charge represented would change the potential above that electrode by 250 V. The blow-off signal is much larger, but also shorter, and again only accounts for about 20% of the missing charge.

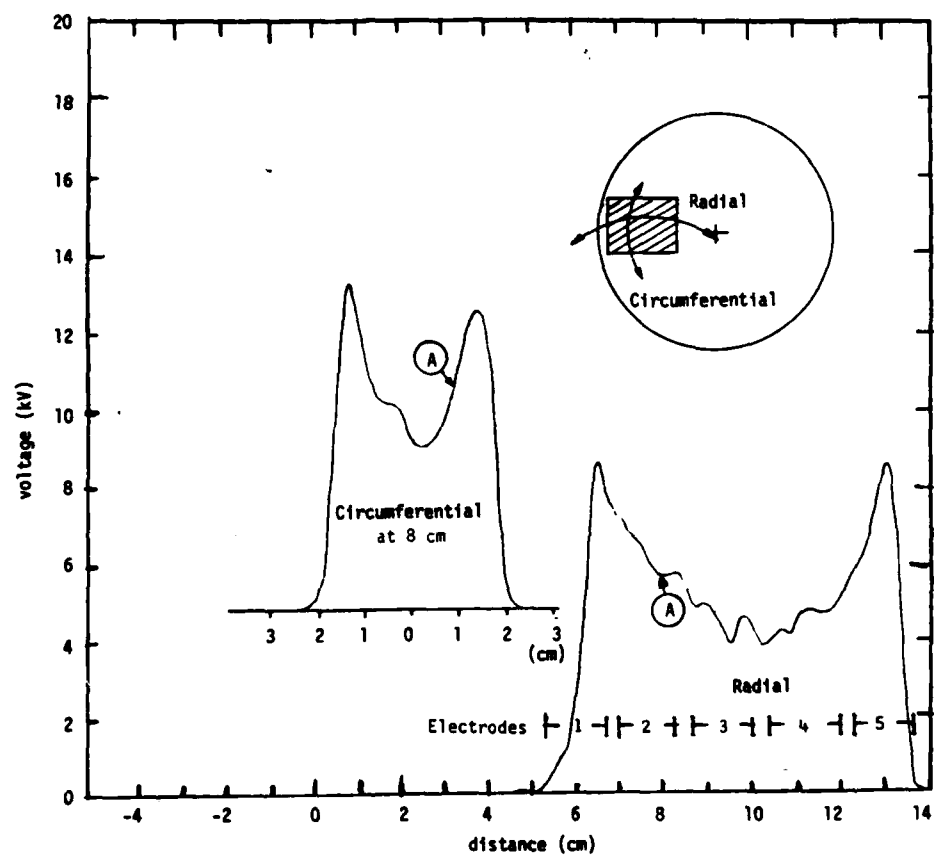
Figure 94. Perpendicular potential profiles on 0.03 cm cover glass intersecting at point A.

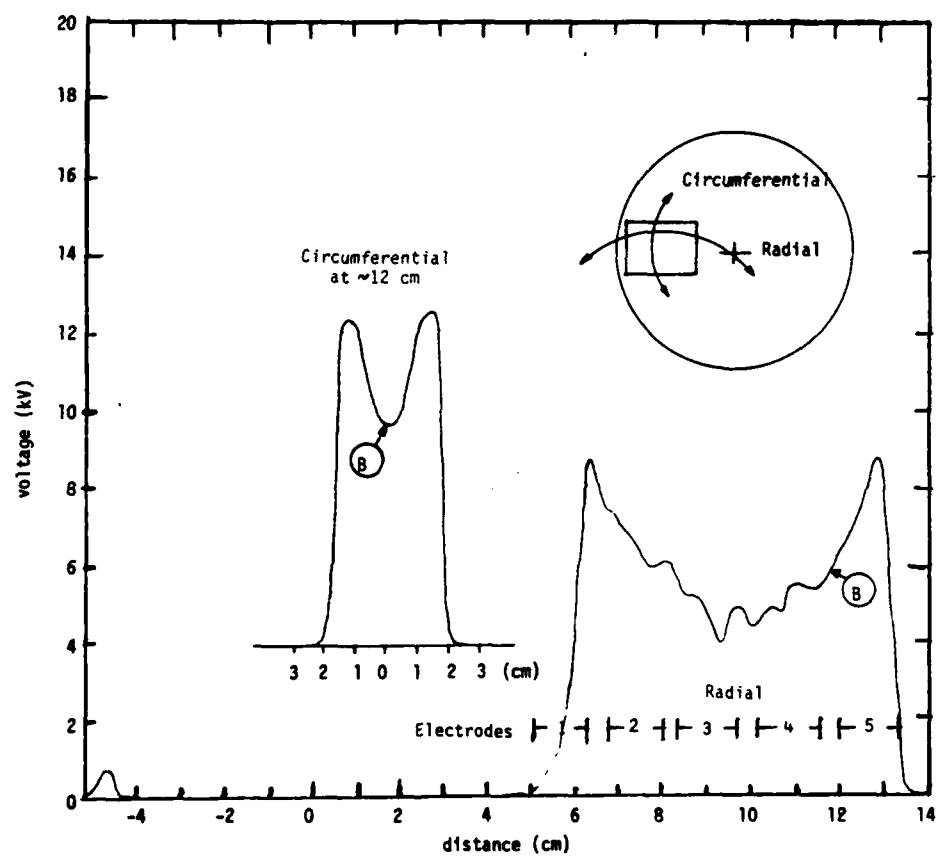
Figure 95. Perpendicular sweeps on 0.030 cm cover glass intersecting at point B.

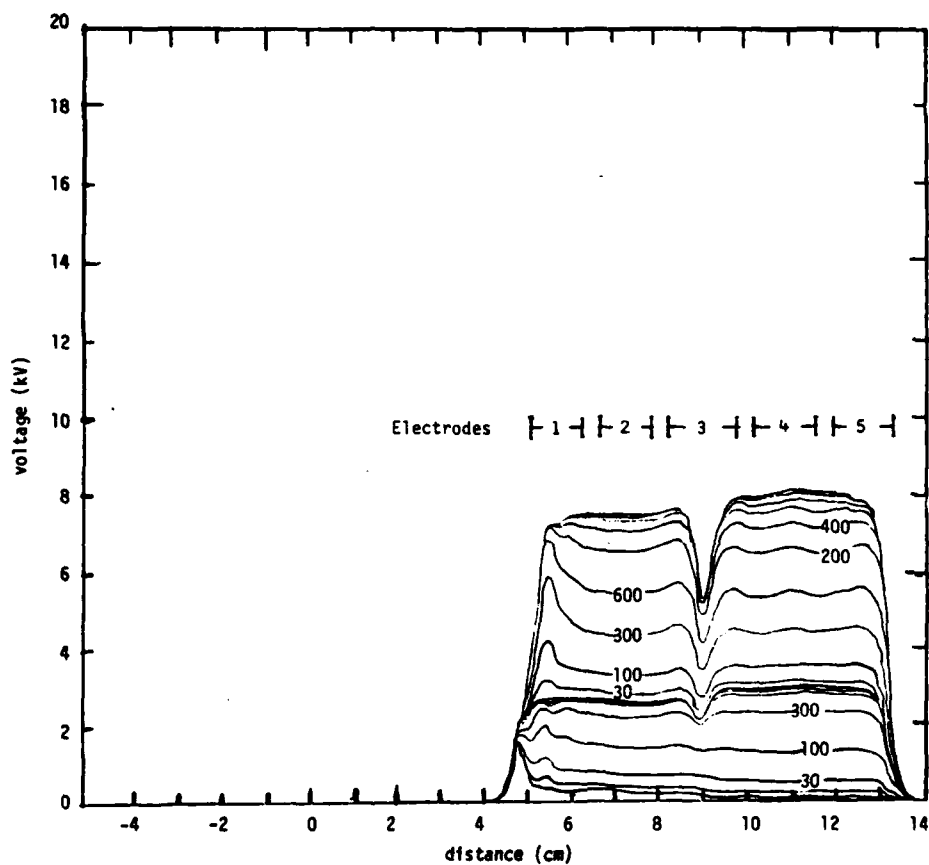
Figure 96. Charging profiles for 0.02 cm thick second surface mirrors. Charging with a) 0.4 ± 0.2 nA/cm² of 6 keV electrons, then b) 0.3 ± 0.1 nA/cm² and 0.55 ± 0.15 nA/cm² of 11 keV electrons. Charging times for the sweeps shown were a) 10, 30, 100, 300, 600, 800, 1100 seconds at 6 kV, then b) 30, 100, 300, 600 seconds at ≈ 0.3 nA/cm² and 11 kV, the c) 200, 400, 600, 800, 1100, 1400 seconds at 0.55 ± 0.15 nA/cm² and 11 kV.

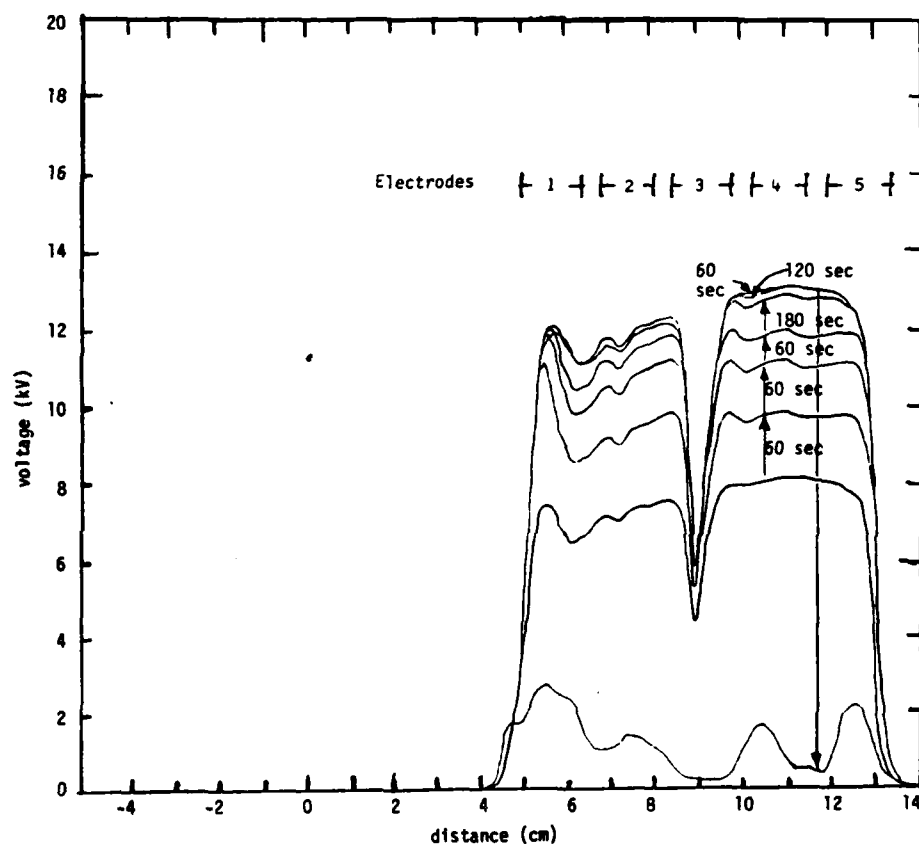
Figure 97. Continued charging of 0.02 cm glass mirrors with 2 nA/cm² of 16 keV electrons, then a discharge induced by 200 nA/cm² of 16 keV electrons.

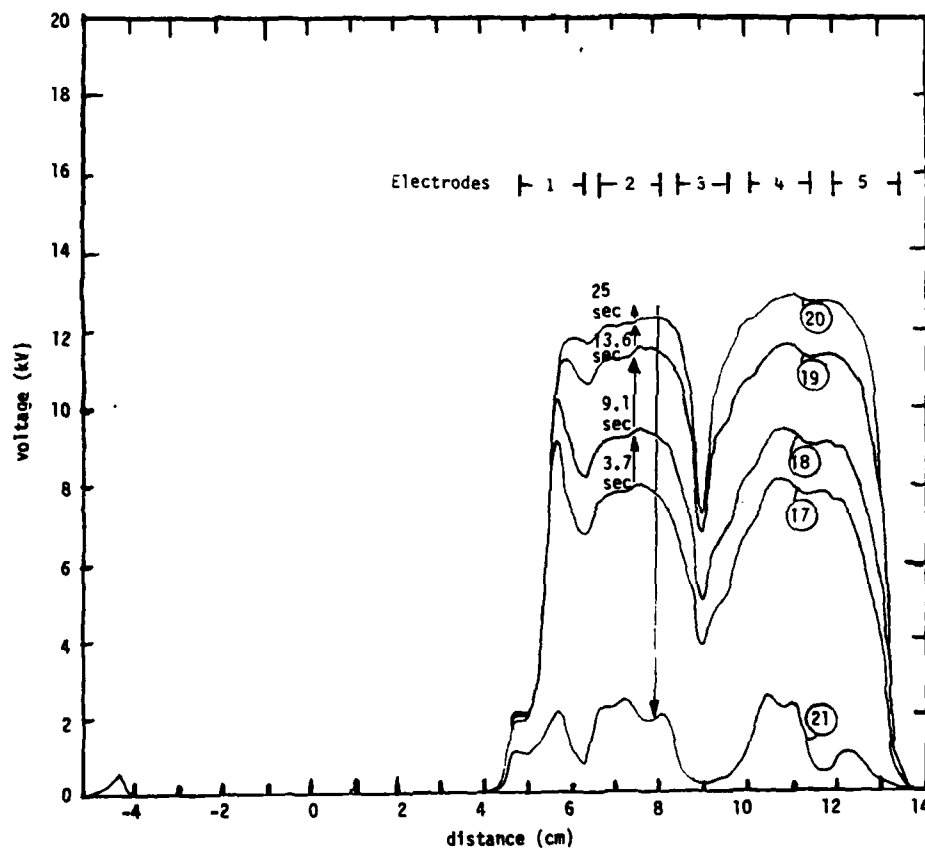
Figure 98. Recharging profiles of 0.020 cm second surface mirrors with 20 nA/cm^2 of 16 keV electrons, leading to discharge 3:04.

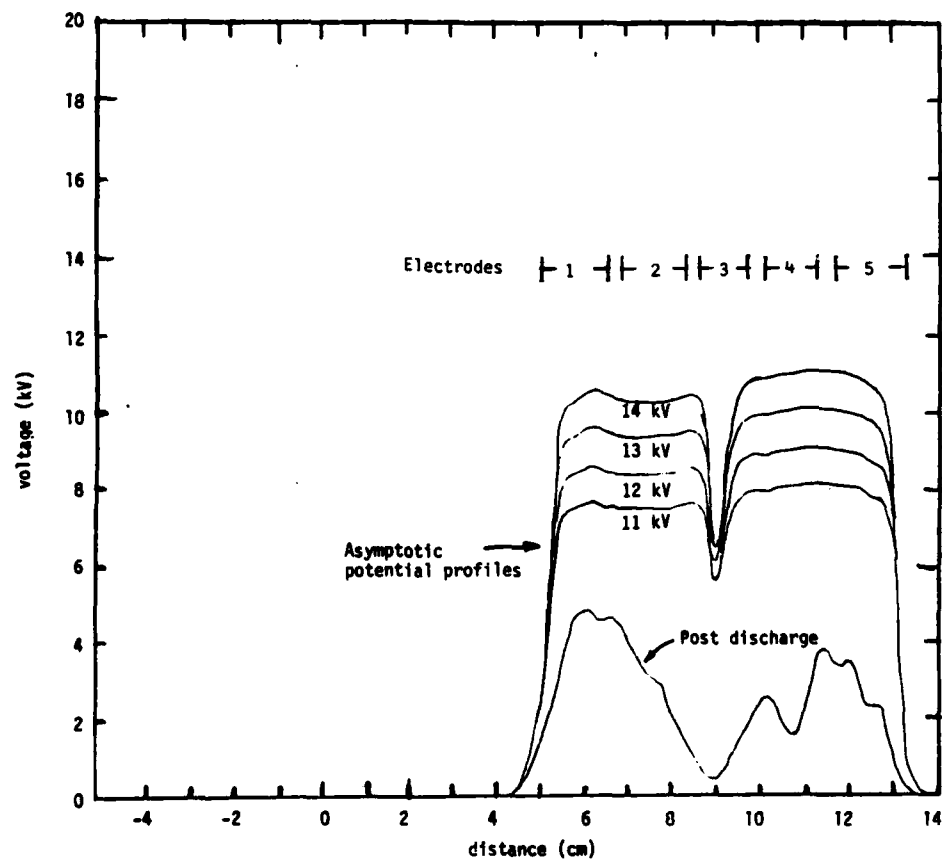
Figure 101. Asymptotic profiles for 0.020 cm second surface mirrors exposed to 10 nA/cm^2 . Beam energy at 11 kV, 12 kV, 13 kV, 14 kV. Discharge with beam at 15 kV.

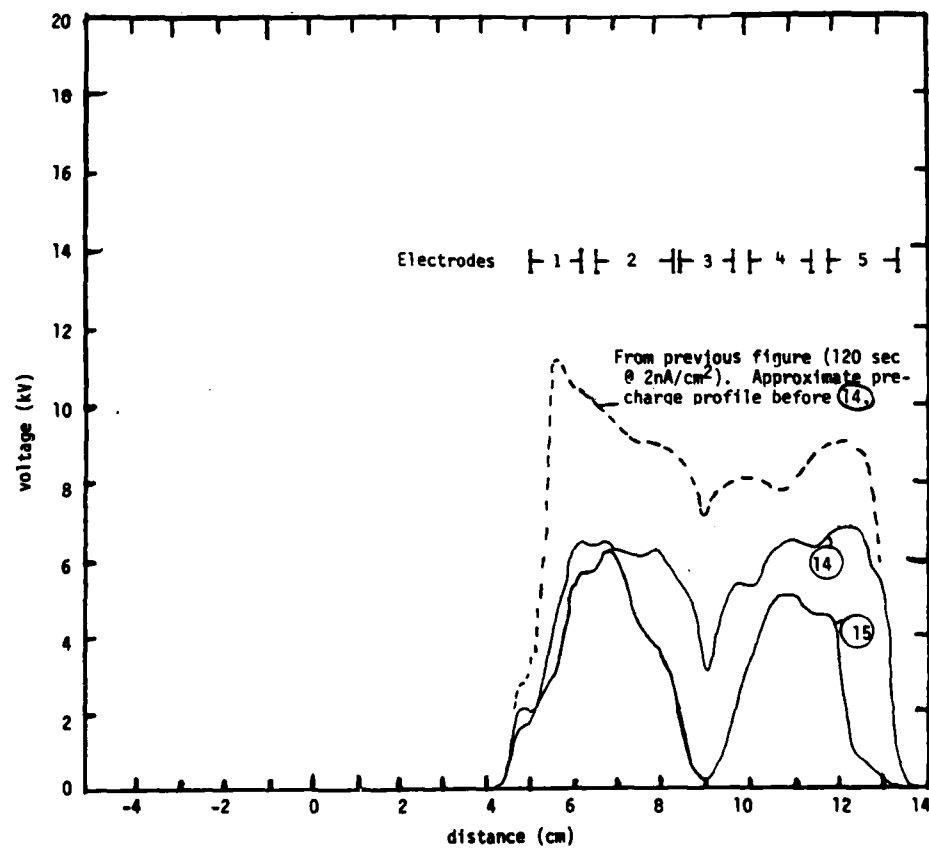
Figure 103. Post-discharge profiles for 0.020 cm second surface mirrors after events 11:52 and 12:09. Estimate of profile before event 11:52.

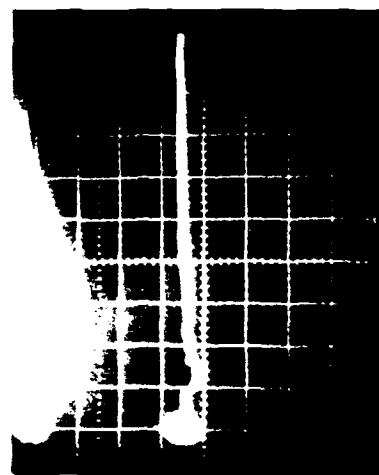
Figure 104. Transient record of discharge 11:52 on 0.020 cm second surface mirrors exposed to 16 kV electrons.

Figure 104 shows transient records from event 11:52. In this event, Channels 4 and 5 show no signal, from which we infer that mirror 2 did not participate in the event at all. Channels 1, 2, and 3 show similar positive signals to begin the event, lasting about 50 ns. Then, channel 1 goes strongly positive, and channels 2 and 3 go negative. We interpret this to mean that the event began as a "blow-off" and then became a "punch-through" or "flash-over" (around the edge) onto electrodes 2 and 3. The blow-off collector supports this interpretation, showing a negative signal for the first 50 ns, and then very little. Visually, the event appeared as a few tiny bright points along the joint between the two mirrors.

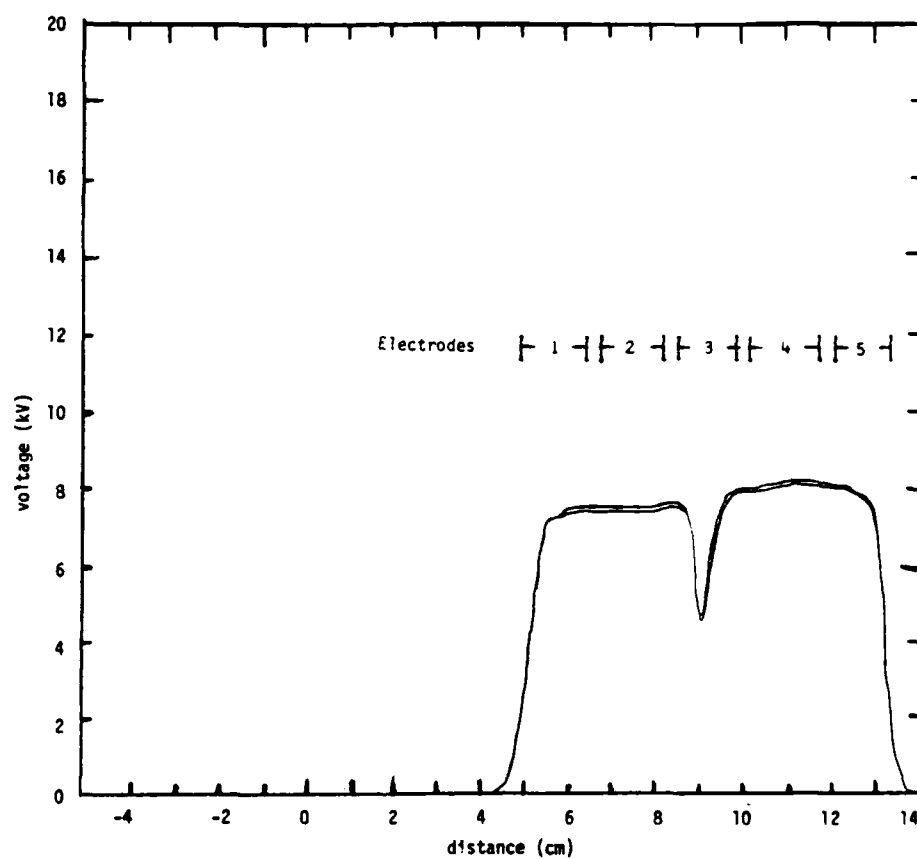
Figure 106. Decay of voltage profile on 0.020 cm second surface mirrors after 38 hours.

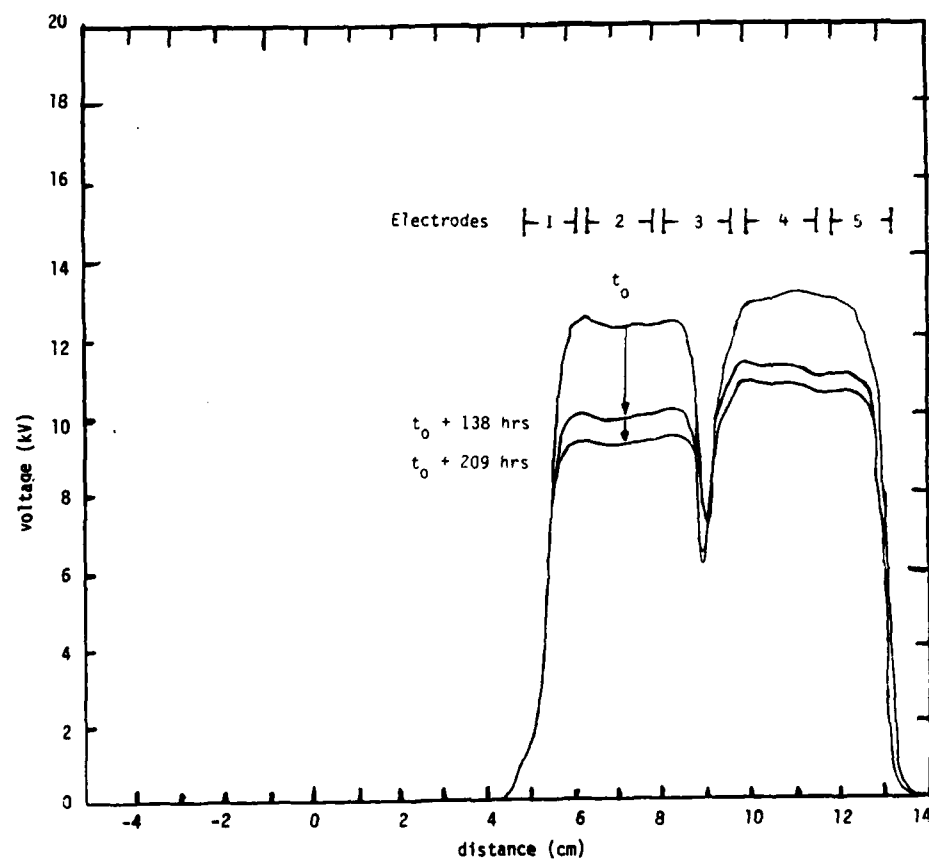
Figure 107. Decay of voltage profile on 0.020 cm second surface mirrors over 138 hours, then 71 hours.

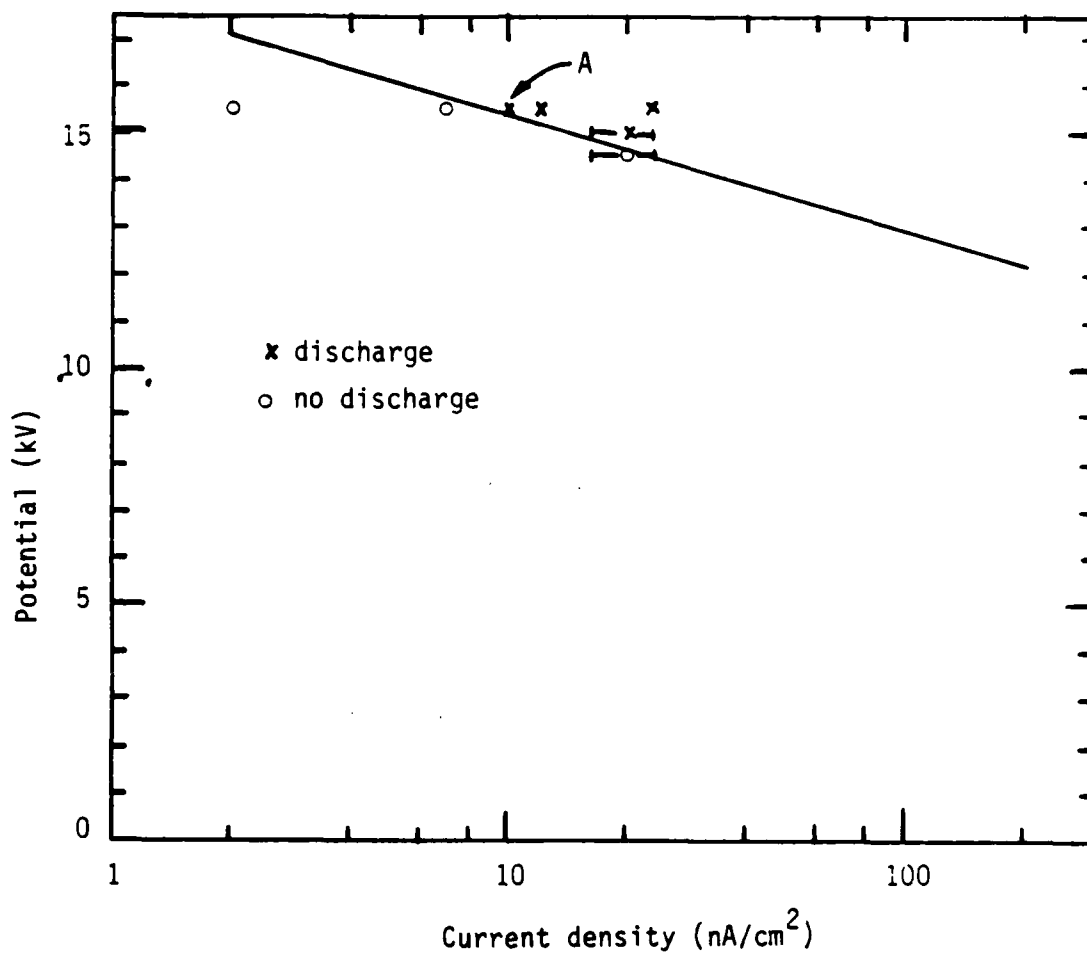
Figure 109. Stability of breakdown as a function of beam current and energy. Second surface mirrors.
